ES_LPC43S6x Flash Errata sheet LPC43S6x flash-based devices

Rev. 1.3 — 24 September 2019

Info	Content
Keywords	LPC43S67JET256; LPC43S67JBD208; LPC43S67JET100; ARM Cortex-M4 flash-based devices, Rev A errata.
Abstract	This errata sheet describes both the known functional problems and any deviations from the electrical specifications known at the release date of this document.
	Each deviation is assigned a number and its history is tracked in a table.

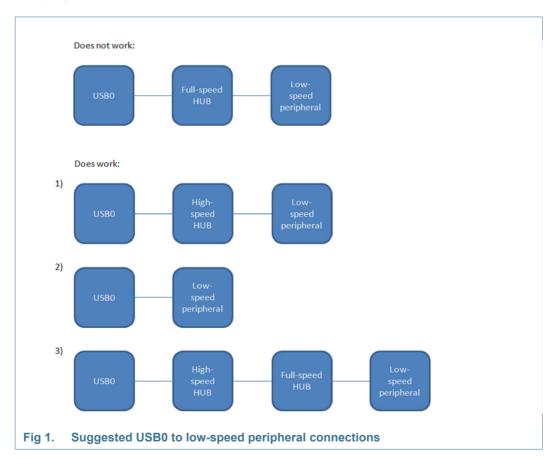
The USB controller called USB0 is unable to communicate with a low-speed USB peripheral in host mode when there is a full-speed hub directly connected to the USB0 port and a low-speed peripheral is connected in the tree somewhere below this full-speed hub. Only USB0 has this problem; the other USB controller, USB1 does not.

There is no work-around for this problem. It is suggested that the low-speed USB peripheral is either connected directly to USB0 or a high-speed hub is placed between that peripheral and USB0.
