# 68060 ERRATA

Rev 4.0 - 10/18/96

## 060 Production Masksets

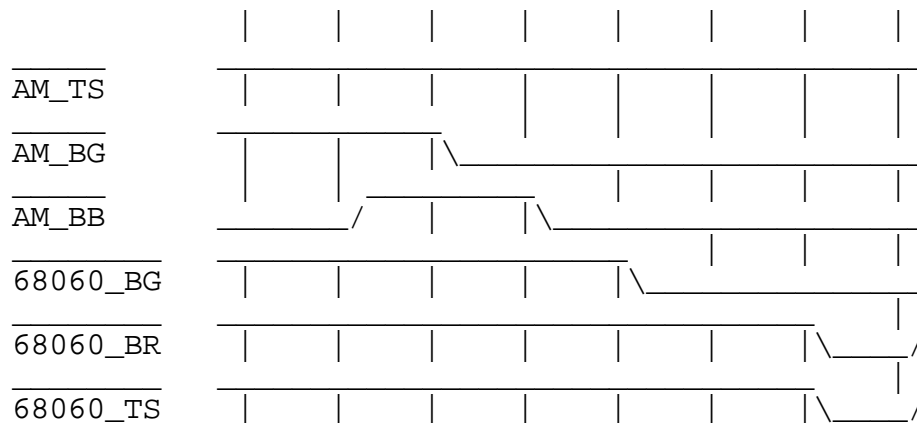
H4 - In systems with at least one alternate master which asserts only BB and not TS during bus tenure the 68060 may incorrectly take over bus mastership. This occurs if BG is asserted to both the alternate master and 060 where the alternate master had, at some time in the past, used the bus, relinquished the bus and started to use the bus again with no intervening bus cycles that assert TS. In this case, the 060 may run bus cycles if an internal request is pending without waiting for the alternate master to finish using the bus and negate BB.

The following timing diagram will illustrate this case.

Workarounds include:

Have the alternate master assert TS when it starts bus cycles

Assure that the bus grants to an alternate master and 68060 are mutually exclusive

Do not assert BG to the 68060 until the alternate master is done using the bus.
