MCF5485 Chip Errata

Silicon Revision: All

Supports: MCF5480, MCF5481, MCF5482, MCF5483, MCF5484, and MCF5485

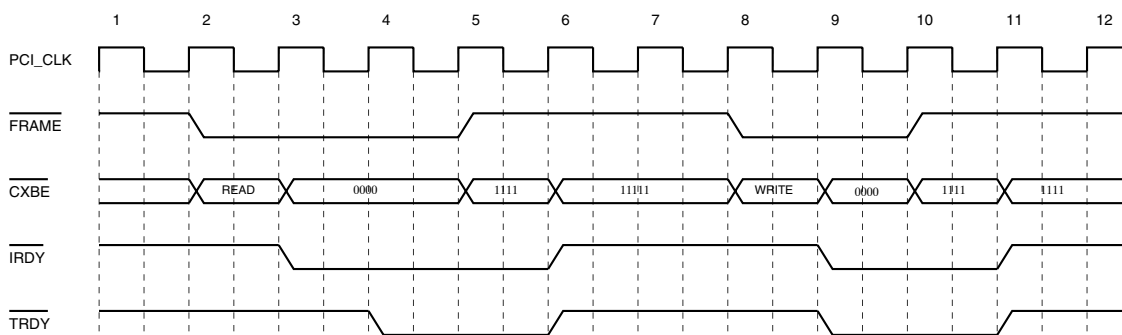
Figure 1. PCI bus 2-beat transfer

Description: As shown below, an unexpected 2-beat transfer is issued on the PCI bus when a Type 1 configuration PCI cycle is performed using the Configuration Mechanism and more than 3 bytes are being transferred. The byte enables are correctly driven, but a second false data transfer is issued.

For writes, there is no harm done other than one or more (if a disconnect occurs) wasted PCI cycles for the false data transfer. During reads, two beats of data, the good data and the false data, are pushed into an internal read data FIFO and only one is popped off the FIFO. The first 32-bit read completes as expected. Any read following this read, causes the transaction on the PCI bus as expected. However, internally the data returned for this next read is not new data but what remained in the FIFO from the first two-beat read, the second false data transfer. The addition of the false data in the read FIFO causes subsequent reads to be out-of-sync with the data in the FIFO.

Workaround: Only issue byte or 2-byte type 1 configuration reads. Addresses at byte offsets retrieve the correct bytes. This avoids the two-beat read transactions.

Workaround: Use the SPCPI RX interface to issue 32-byte type 1 configuration reads to PCI.

Workaround: After issuing a 32-bit type 1 configuration read via the configuration mechanism (using PCICAR), clear the read data FIFO of the false data by immediately issuing an XLB transaction that results in a master abort. For instance, after a type 1 configuration read (to bridge), change the bus number in the PCICAR to an unused bus and issue another type 1 configuration transaction (read or write). A read returns all 1s. The master abort status bits flag, PCISCR[MA] and PCIISR[IA]. If subsequent configuration reads across the bridge are needed, reprogram the bus number to the valid value and continue interleaving the master abort transaction between each.
