## Mask Set Errata

MSE912DT128P\_2L05H  
Rev 0.0, 01/2003

Mask Set Errata for  
68HC912DT128P  
Mask 2L05H

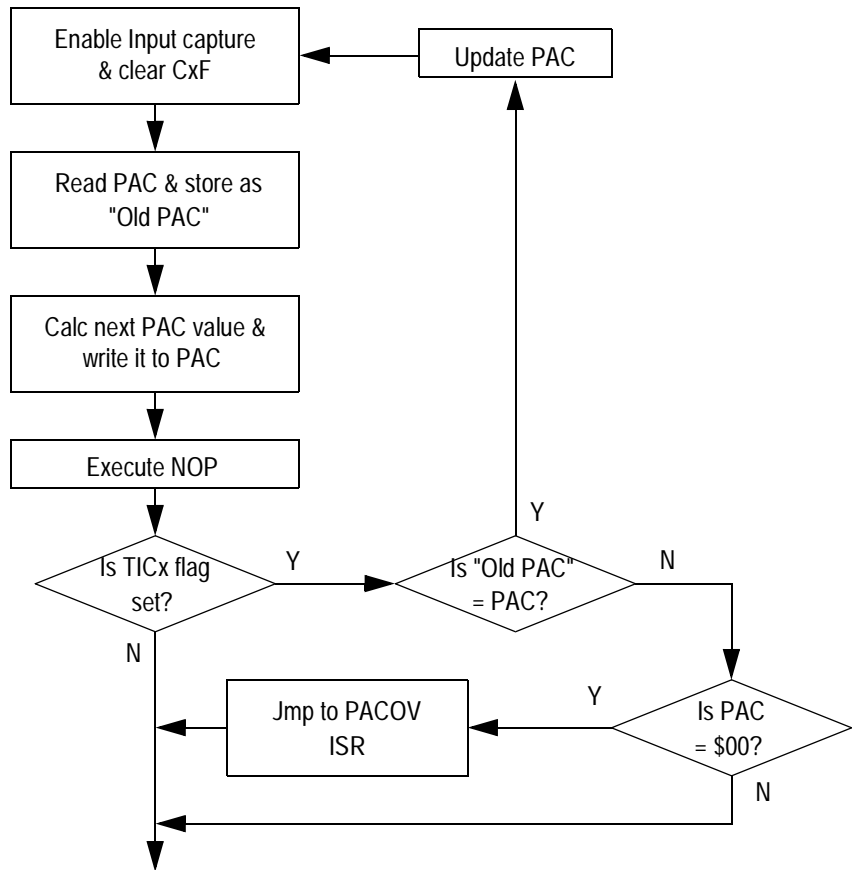
## PA Overflow flag not set when event is concurrent with write of \$FFFF Errata Number: HC12\_AR\_644

**Description** When the value \$FFFF is written to PACA or PACB and, at the same time, an external clocking pulse is applied to the PAC, the pulse accumulator may overflow from \$FFFF to \$0000, but the pulse accumulator overflow flag [PAFLG,PBFLG] is not set. Same situation may happen with 8-bit pulse accumulators PAC1 and PAC3.

**Workaround** The input capture function for the subject channel be enabled prior to writing a value to the PACA or PACB. Write to the pulse accumulator register. Then do one NOP (to allow the input capture to update the interrupt flag) followed by a read of the input capture interrupt flag to see if it set. If yes, a check must be made for a missing pulse accumulator event. Steps for software workaround to see if event happens while writing to PAC:

1. Enable Input Capture on same pin as the pulse accumulator (and same type of event).
2. Clear the appropriate CxF in the timer interrupt flag register.
3. Read PAC and store as "Old PAC".
4. Calculate desired PAC value and write it to the PAC.
5. Execute 1 NOP.
6. Read CxF in the timer interrupt flag register.

If flag is not set, done (no events happened while writing to the PAC).

If flag is set read PAC

If "Old PAC" = PAC, then update PAC (event happened while writing to PAC and the PAC did not capture it). Note, if the updated PAC value is \$00 jump to PACOV ISR.

If "Old PAC" does not equal PAC, does PAC = \$00 ?

If yes, jump to PACOV ISR.

If no, done (event happened while writing to the PAC and PAC captured it). Read CxF in the timer interrupt.
