# Mask Set Errata for Mask 1M75B

This mask set errata applies to the mask 1M75B for these products:

- MC9S08AW60
- MC9S08AW48
- MC9S08AW32
- MC9S08AW16

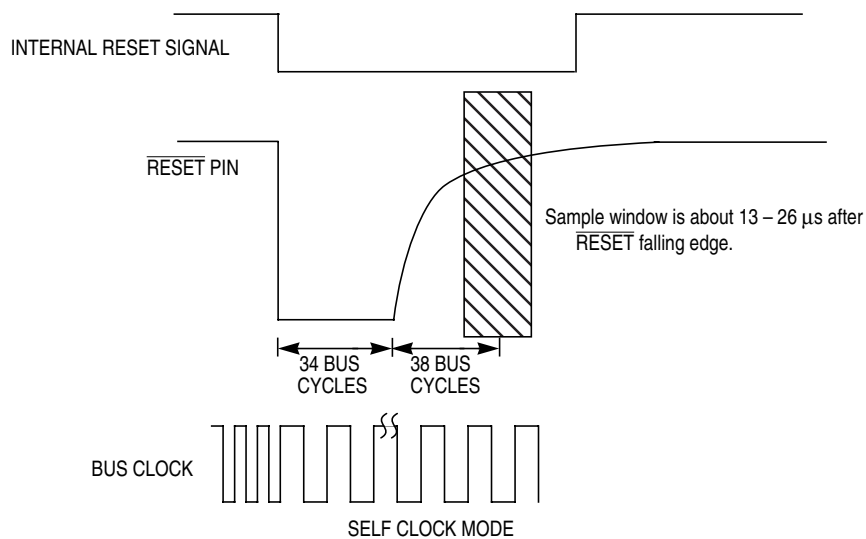
**Case 1** — After detecting a reset signal, either internal or external, the internal reset circuit latches the cause of the reset, forces a low level on the external  $\overline{\text{RESET}}$  pin for about 34 bus cycles, releases the pin, and samples the pin level about 38 bus cycles later. The ICG will revert to self-clock mode (SCM) at the beginning of the reset cycle. Therefore, the first sample window is about 13  $\mu\text{s}$  to 26  $\mu\text{s}$  after the initial reset signal, due to the frequency range and characteristics of the internal oscillator.

### Workaround — Case 1

To avoid multiple edges on the  $\overline{\text{RESET}}$  pin due to switch contact ringing or EMC noise, eliminate any voltage bounce through RC filtering. A 0.1  $\mu\text{F}$  capacitor to ground and an external 4.7 k $\Omega$  to 10 k $\Omega$  resistor to  $V_{DD}$  works well to ensure noise suppression.

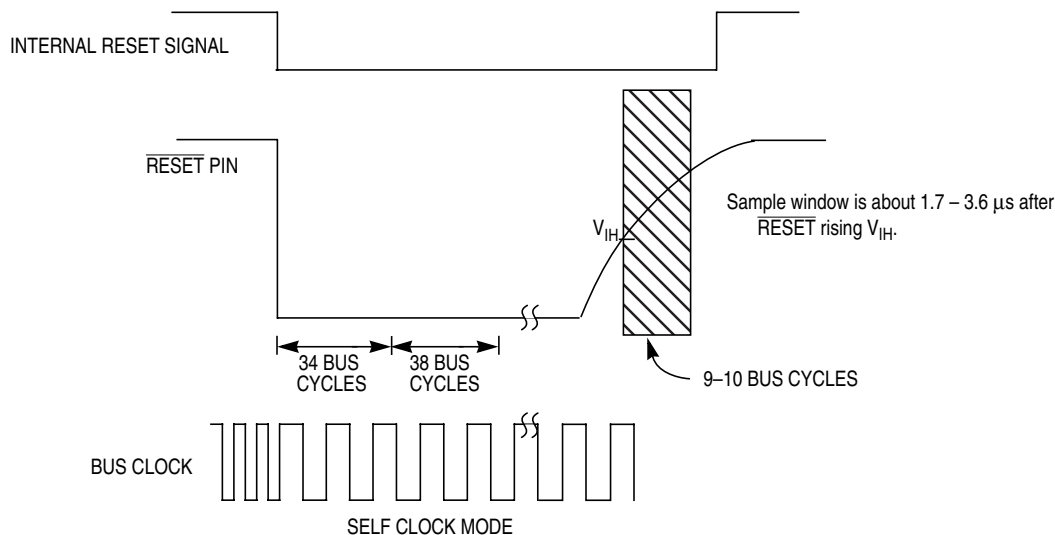
**Case 2** — After remaining in reset for an extended period of time due to an externally applied low level on  $\overline{\text{RESET}}$ , the internal reset circuit will sample the pin level about 9 to 10 bus cycles after the pin raises above its  $V_{IH}$  level. The ICG will revert to self-clock mode (SCM) during reset. Therefore, the second sample window is about 1.7  $\mu\text{s}$  to 3.6  $\mu\text{s}$  after the reset signal rises above  $V_{IH}$ , due to the frequency range and characteristics of the internal oscillator.

### Workaround — Case 2

In addition to RC filtering, avoid spurious edges on the  $\overline{\text{RESET}}$  pin caused by external active circuitry such as low voltage detectors and watchdog components. Do this by ensuring that external circuitry cannot drive  $\overline{\text{RESET}}$  low within 10 bus cycles of the release of  $\overline{\text{RESET}}$ .

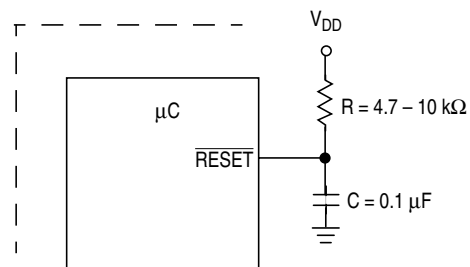
**Figure 1. HCS08 SIM Reset Lockup**

If a falling edge is detected on the external reset pin at either of two sample points, the MCU will cease operation and will recover only after a power-on reset.
