Altimus X3B Evaluation Board Errata

Rev. F, 9/2005

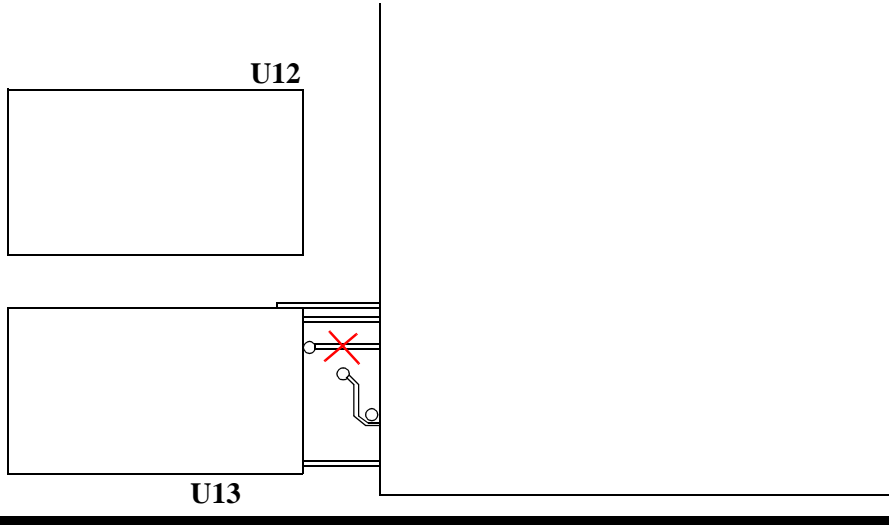
Errata 14 Details

13	Design	Interrupts not receivable on IRQ0* (in spite of errata #12) when not in SYSCON* mode, which is true on SPX# systems with serial numbers ≥ 6000 , or when SYSCON is not selected.	Lack of interrupts on IRQ0*.	1. Add a wire or solder-bridge across U2 (QS3384) pins 12, 13 and 14. Note: For SPX3 systems ≤ 5999 : Select MPMC mode on the MPMC and SPX3 (SYSCON LED should be active). For X4: Connect INTA# to IRQ0# with no QS involvement (new standard method).	E
14	Device/Design	The MPC7410 will drive L2ADDR[17] (normally unused) high in 1MB private memory mode or with 2MB L2 configured as half cache, half private memory, it will drive L2ADDR[17] high for the private memory accesses. MPC755-equipped Altimus boards do not need this rework.	Private-memory modes do not work for some modes/sizes (cache works fine).	For MPC7410: 1. On the top of the board, between the processor and the SRAMs, cut the trace shown on the detail view. 2. Change R67 to 22 ohms. This disconnects CA17 from the processor, and R67 pulls CA17 low. For X4: Disconnect CA17.	F
