Functional Differences Between The 1F90S Mask of the DSP56302 and the 0J17D Mask of the DSP56309

Functional Differences Between The 1F90S Mask of the DSP56302 and the 0J17D Mask of the DSP56309, Rev. 2

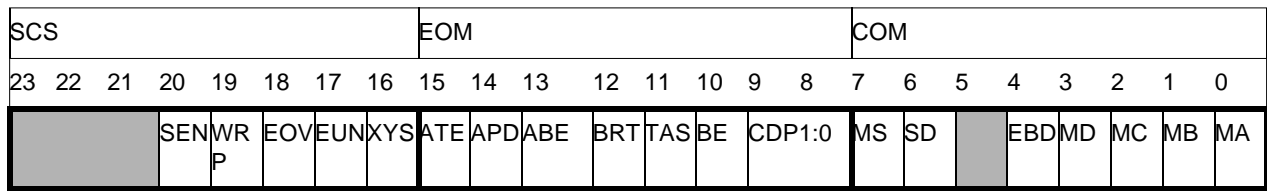
Figure 1. Operating Mode Register (OMR)

In the Operating Mode Register (OMR) of the 0J17D is a new Asynchronous Bus Arbitration (ABE) bit to support external access at high frequencies. As **Figure 1** shows, bit 13 in the OMR enables Asynchronous Bus Arbitration. For convenience, **Table 2** defines all the OMR bits available in the 0J17D mask set of the DSP56309. The ABE bit is highlighted in a bold red font.

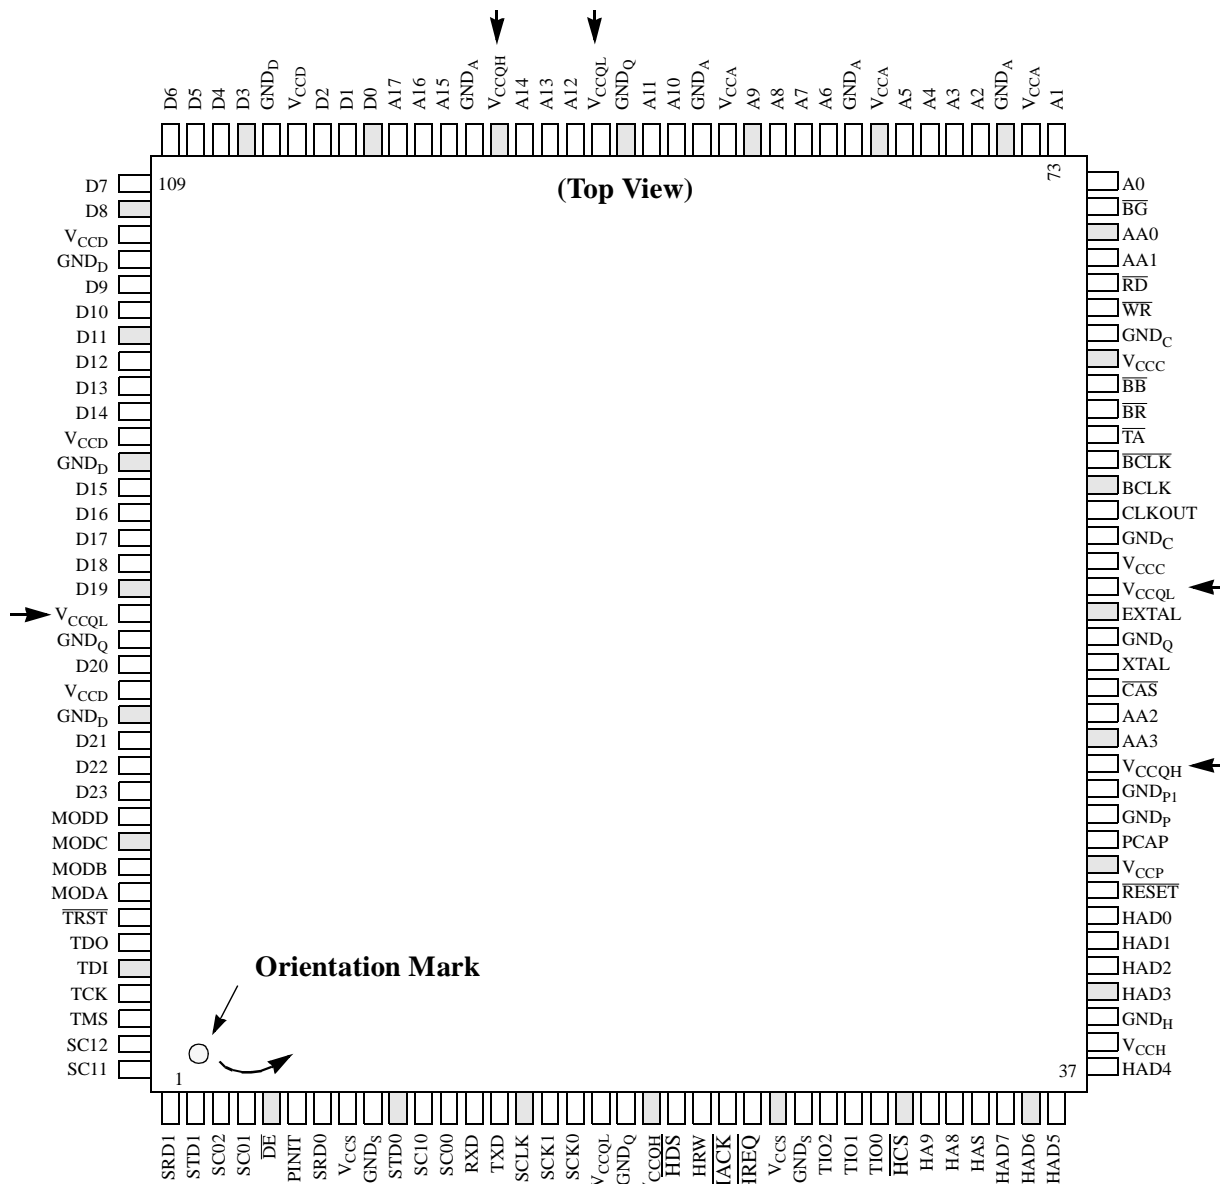
Figure 4. DSP56309 Thin Quad Flat Pack (TQFP), Top View

The DSP56309 Rev A uses a split-power design and therefore requires a modification in the chip pinout. A top view of the DSP56309 Rev A TQFP package is shown in **Figure 4**. **Table 3** lists the pin differences between the DSP56302 and the DSP56309.

Note: Arrows (→) indicate the pins that are different from the DSP56302, as listed in Table 3, on page 7.
