Migration from MPC8313E Revision 1.0 to Revision 2.x

by *NMG Applications*
Freescale Semiconductor, Inc.
Austin, TX

This document explores the migration from silicon revision 1.0 to 2.x with respect to software, hardware, internal module revision, and chip pin assignment, and serves as a relevant guide for both software and hardware developers.

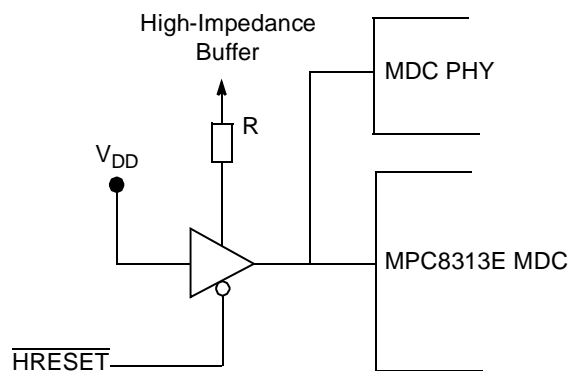
To disable ECC checking on revision 2.x, use a high-impedance buffer on the board, as shown in Figure 1, to drive a strong pull up on the TSEC1_MDC pin while $\overline{\text{HRESET}}$ is asserted. If a strong external pull up of at least 1.5 k Ω on the TSEC1_MDC pin has already been added, but ECC checking during boot time is desired, a high-impedance buffer will need to be used to activate this external pull up only after $\overline{\text{HRESET}}$ is negated. If no change in ECC check enable/disable is intended, no changes are required. These options have been implemented on the revision 2.x RDB board with a dip switch, high-impedance buffer, and non-populated pull up on TSEC1_MDC.

Figure 1. Recommended Circuit for Disabling ECC Checking at Boot Up

New Feature Required (Ability to Disable ECC Checking)	Pull Up Exists on MDC	Pull Down Exists on MDC	Recommendations
No	No	No	No changes required
No	No	Yes	The external pull down will be in parallel to the internal 10k pull down. If the effective resistance becomes too low, it may hamper the TSEC1_MDC signal. It is recommended that the external pull down be removed.
No	Yes	No	Depending on the value of the external pull up, it may form a potential divider, which may be affected while booting and also on the TSEC1_MDS signal. It is recommended that the external pull up be removed.
Yes	No	No	Add circuit as shown in Figure 1 .
Yes	No	Yes	Remove pull down and add the circuit as shown in Figure 1 .
Yes	Yes	No	Isolate pull up with high-impedance buffer as shown in Figure 1 .
